NACA RM E51D16

INVESTIGATION OF MECHANISMS OF BLADE FAILURE OF

FORGED HASTELLOY B AND CAST STELLITE 21

TURBINE BLADES IN TURBOJET ENGINE

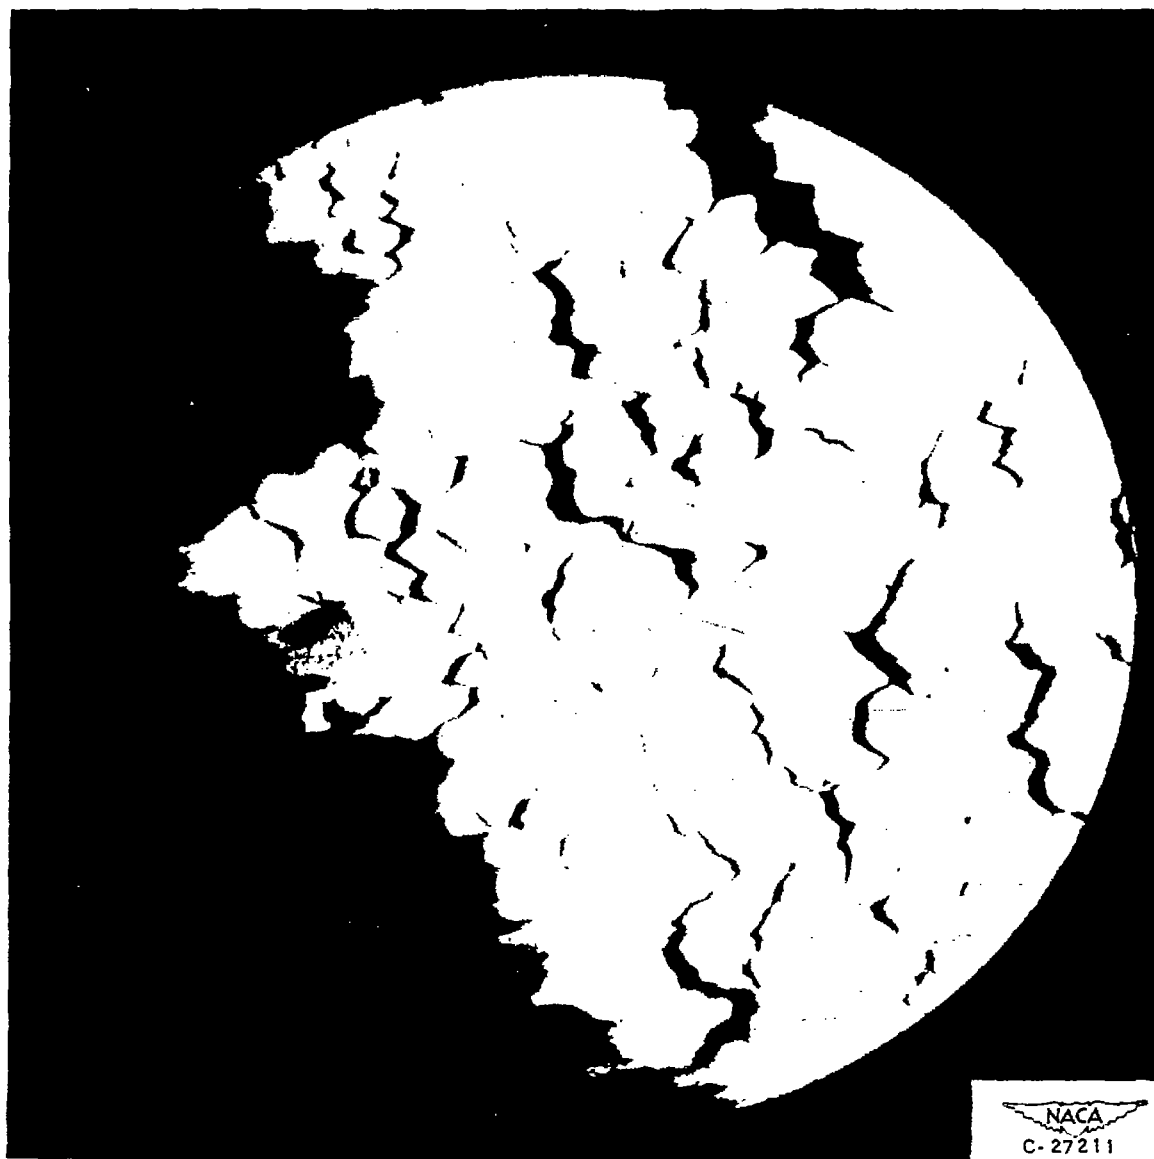
Figure 5. - Intercrystalline fracture in Hastelloy B stress-rupture specimen. Etched in solution of aqua regia in glycerine. X50.

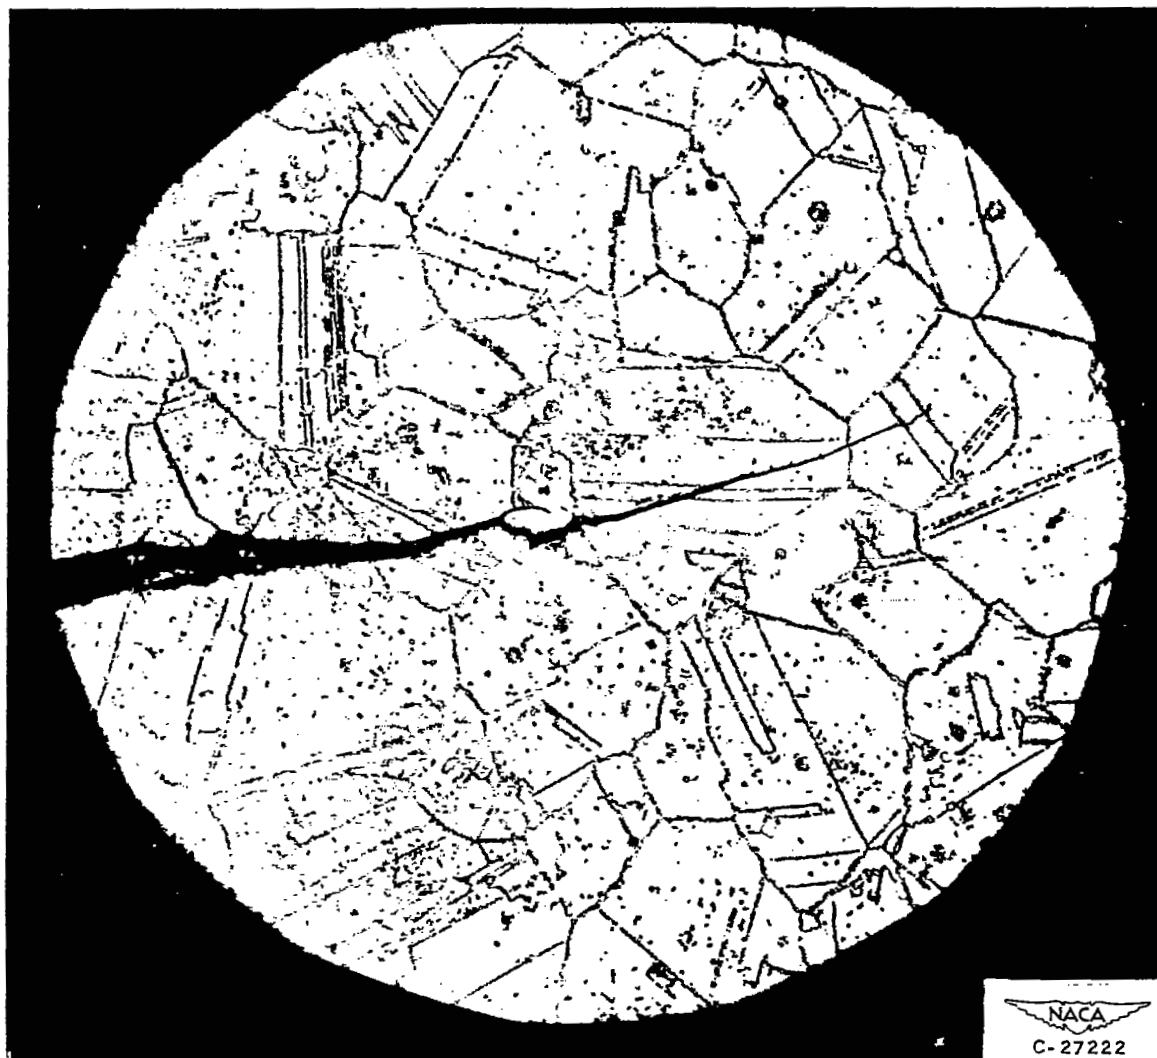
Figure 8. - Transcrystalline trailing-edge crack in Hastelloy B blade 14 after 14.25 hours (57 cycles) of operation. Etchant, aqua regia in glycerine. X250.

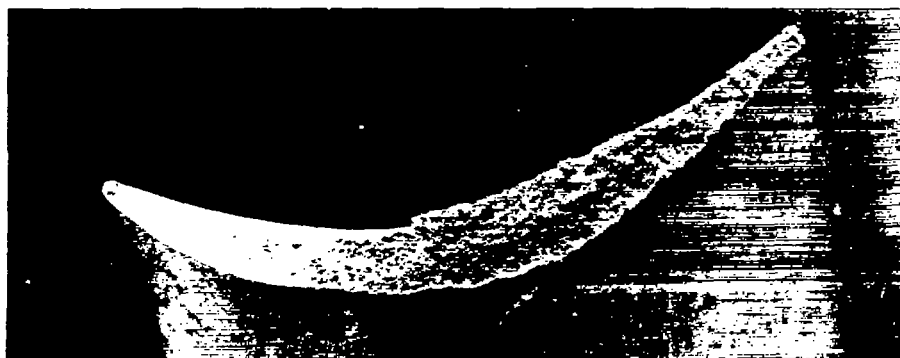
Hastelloy B	4 ^c	16.47	Leading-edge fracture	Fracture started normal to edge from point where crack was observed then changed direction and moved at angle with horizontal. The surface in flat portion of fracture has concentric-ring markings typical of fatigue failure. The remaining surface has coarse appearance (figs. 11(b) and 11(c)).	Interocrystalline changing to transcrystalline (fig. 13)	Centrifugal stress at origin, fracture then propagated to vibratory stresses (stress rupture to fatigue)
Hastelloy B	34 ^c	16.47	Extension of leading-edge crack (crack only)	Same as start of fracture in blade 4 (fig. 11(d))	Interocrystalline changing to transcrystalline (fig. 13)	Same as preceding blade 4
Hastelloy B	54 ^c	26.75 ^e	Leading-edge fracture	Fracture path at angle to horizontal from point where crack was observed. Entire surface has coarse appearance (fig. 11(e)).	Interocrystalline	Centrifugal stress (stress rupture)

(c) Fracture surface of blade 4 (fig. 11(b)). X2.

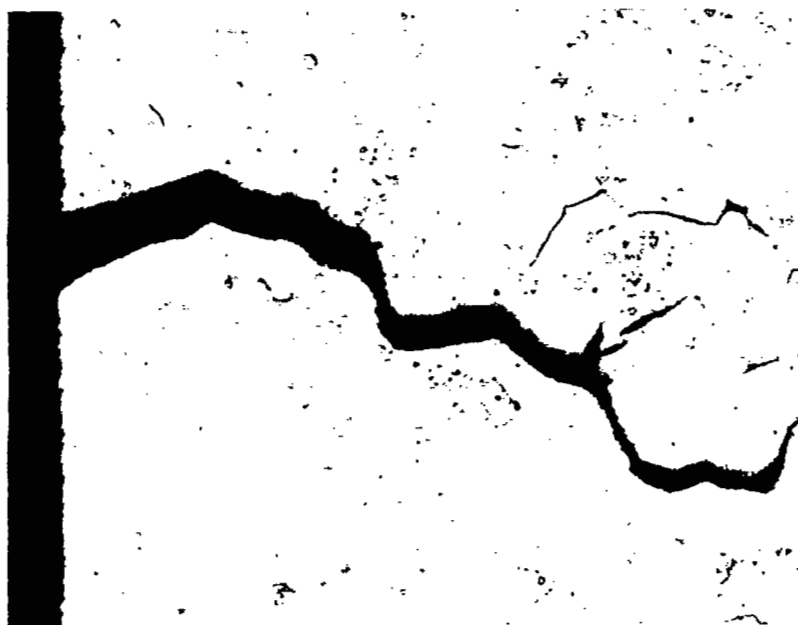
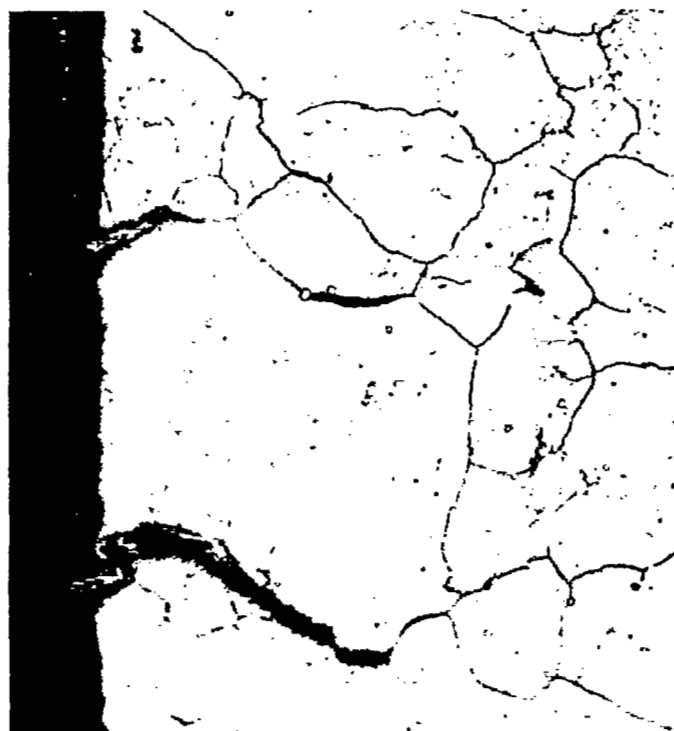
Figure 12. - Typical intercrystalline leading-edge cracks in Hastelloy B blades. Etchant, aqua regia in glycerine.

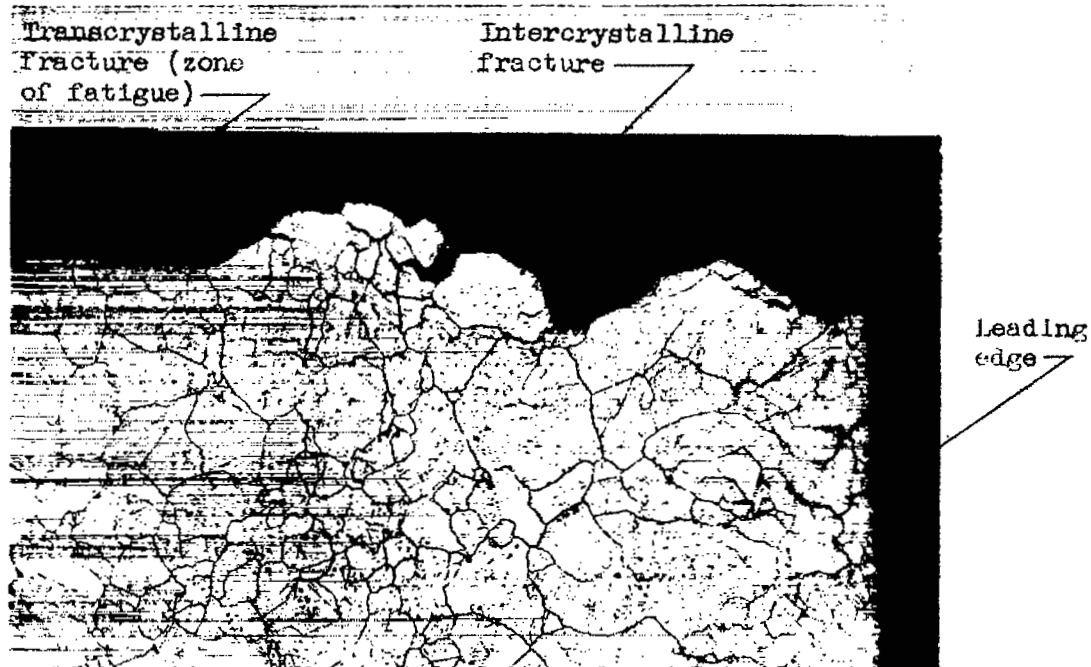
(a) Failure path from leading edge of fractured blade 4. X50.

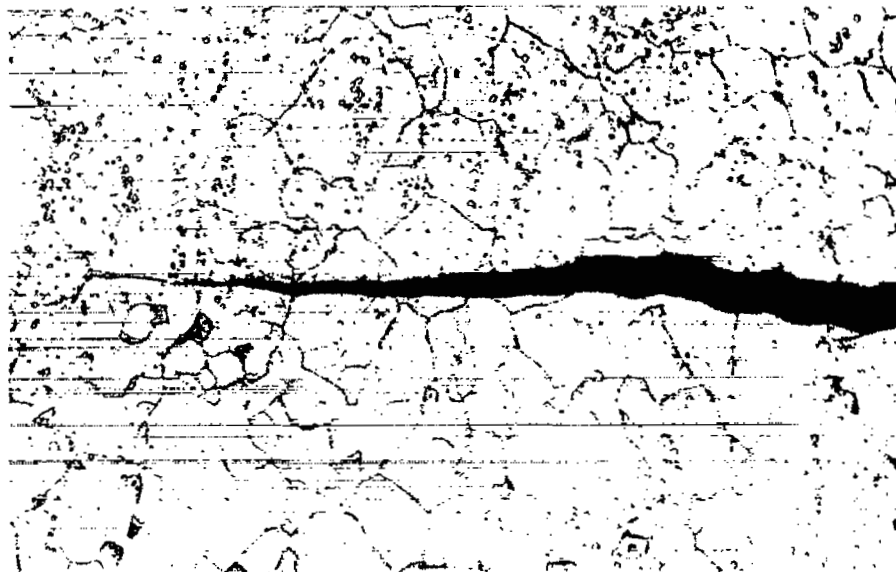
(b) Transcrystalline failure path in zone of fatigue of cracked blade 34. X100.
